WESTERN FIRE CENTER, INC.

Fire Performance of Research-Scale Wall Assembly

WFCi Report #20087

Report Issued: February 1, 2021

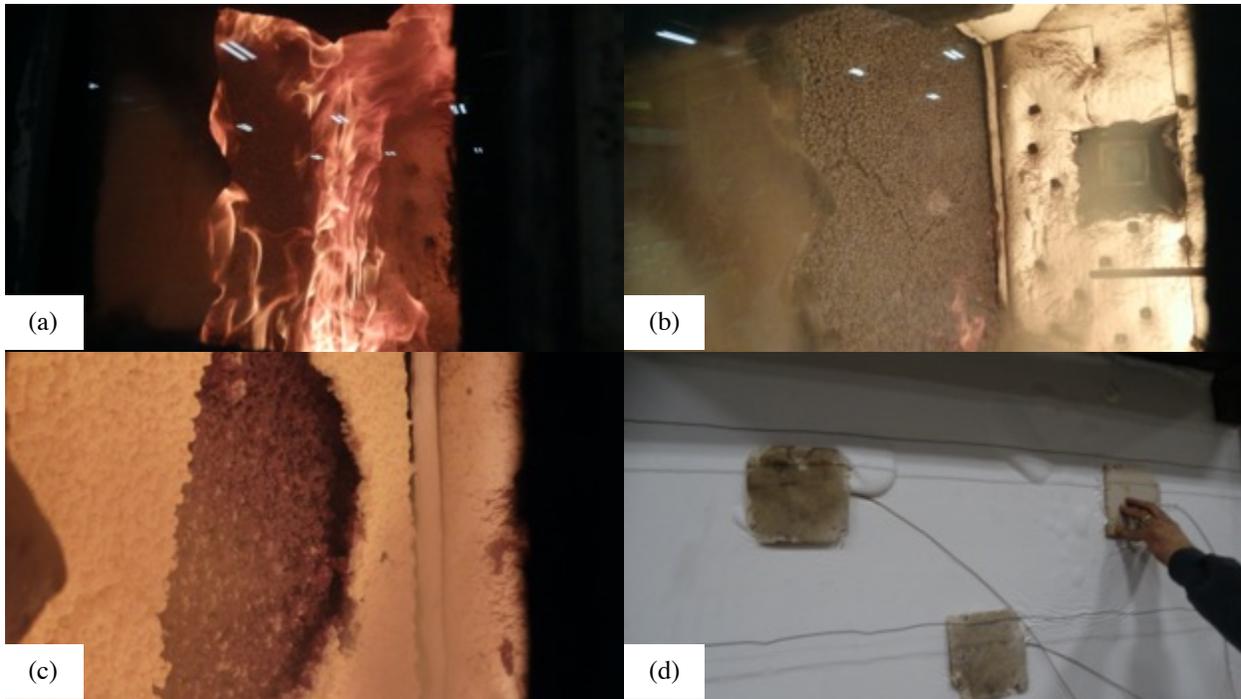
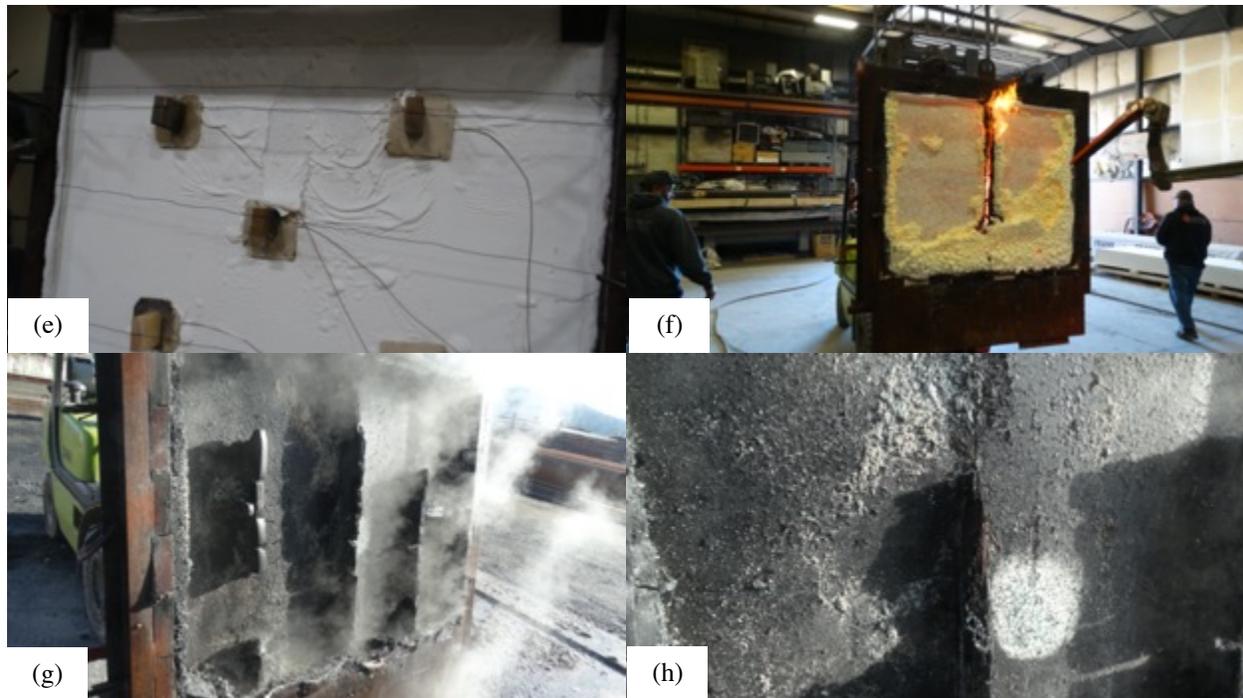
Test Time (hr:mm:ss)	Event
00:00	Start test
01:00	Darkening face
01:20	Flames on face
02:20	Flames reduced – bulbous coating on face approximately 1 cm thick
05:40	Cracking on face – flames again
07:00	Bulging coating approximately 2”
18:00	Bulging approximately 4” – flames mainly fromside/bottom
31:00	Section of coating fell – approximately 12”×16” – coating/intumescent still behind fallen section

34:00	Larger section of coating fell
57:00	Slight cracks/opening at vertical center gypsum joint
1:01:00	Light flames from center joint
1:10:00	Bubbling on unexposed side – sagging TCs/coating – fix blocks to hold pads in place
1:11:30	Exposed flames increased from joint
1:20:00	Wrinkling of unexposed coating
1:23:00	Oozing coating on unexposed side
1:35:45	TCS2 > 196°C – single-point unexposed threshold – assembly failure
1:38:25	TCS1-5 > 154°C – average unexposed threshold
1:39:00	Terminate test

Figure 2. Test 1 wall assembly showing (a) flaming – 2 min, (b) cracking – 6 min, (c) fallen section – 32 min, (d) bubbling – 75 min, (e) oozing – 84 min, (f) from furnace, and (g-h) remaining studs.

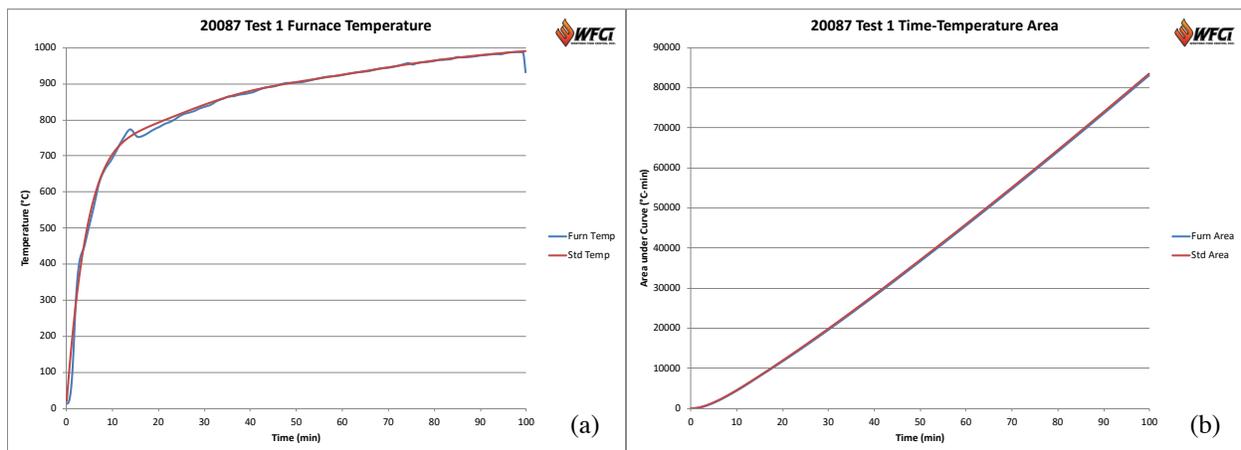
The furnace temperature followed the standard time-temperature curve as shown in Figure 3a. A comparison of the area under the time-temperature curve with the standard is also shown in Figure 3b with 0.4% variation at the end of the test, though well below the 7.5% recommended for a test of 2 hours.

Figure 3. Furnace comparison showing (a) temperature and (b) area under the curve.

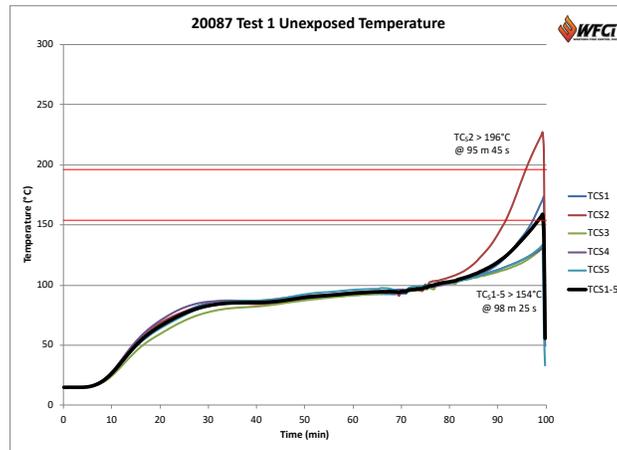
The samples temperatures on the unexposed side are shown in Figure 4. The single-point unexposed temperature threshold ($181^{\circ}\text{C} + \text{ambient}$) was surpassed at 95 m 45 s, or 96 min

rounding to the nearest integral minute. The average threshold ($139^{\circ}\text{C} + \text{ambient}$) was surpassed at 98 m 25 s. This gave the assembly an overall rating of 96 min.

Figure 4. Temperature profiles showing unexposed TC_s.
