WESTERN FIRE CENTER, INC.

Fire Performance of Research-Scale Wall Assembly

WFCi Report #20087

Report Issued: February 1, 2021

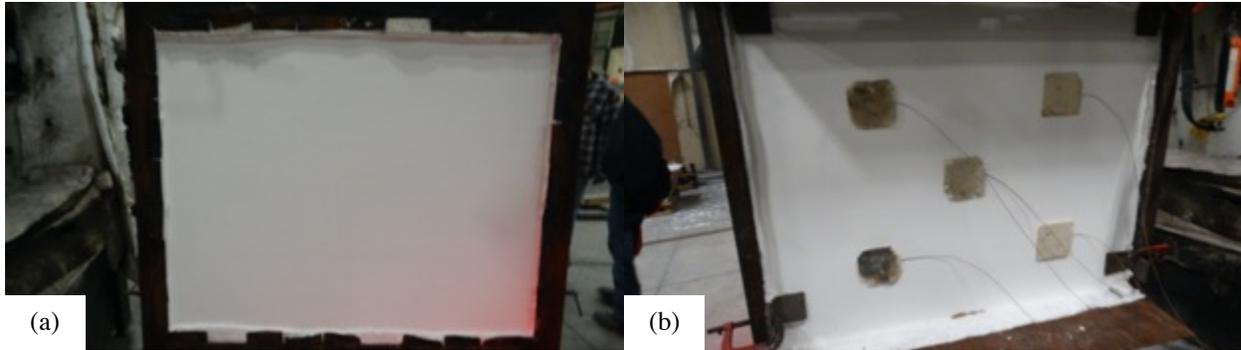
Albi shipped a ready-to-test wall sample (3'11"x4'11", Figure 1) composed of a nominal 2x4 wood frame (16" on center spacing, stud-centered) with one layer of 5/8" Type X gypsum applied to both sides of the frame with appropriate joint compound application. Gypsum was fastened with 1 7/8" Type W screws (8" on center spacing) with a vertical joint along the center stud on both sides. A fire protective coating (Albi Clad FP, 45 mil dry) was applied to each side of the gypsum in multiple coats and allowed to dry at least three weeks prior to testing.

Figure 1. Assembly showing (a) blow-in insulation and (b) assembly in holder.
